LYNG CHURCH

Fredericia, Denmark

Technical Specifications

Roof: 2,000 m², 15 t, Double Standing Seam
RHEINZINK-prePATINA blue-grey

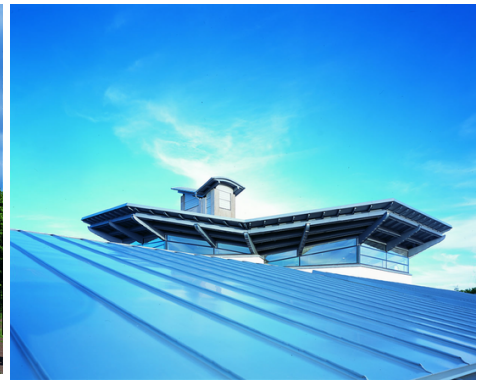
A new zinc cladding in the surface RHEINZINK prePATINA was mounted everywhere at an underlayer of 15 mm high, perforated zinc hat profiles due to extensive rot damage in roof ridges and roof edges. All rotten wood was replaced and painted before the zinc cladding was mounted. By mounting the perforated profiles, an 18 mm. ventilated cavity was ensured between the zinc cladding and the existing wooden structures.

To achieve an optimal airflow, the cladding on the back of all main girders, roof trusses and rafters is made of perforated zinc. The zinc overhang cladding is made with an air gap at all edges - also in perforated zinc. Perforation with a hole diameter of 3 mm. was chosen, as this hole size ensures that bees and other insects are not able to enter the ventilated cavities.
